Polycyclic Aromatic Hydrocarbons (PAHs) in a Residential Driveway Stormwater Sample

Dover, New Hampshire, Great Bay-Piscataqua Watershed

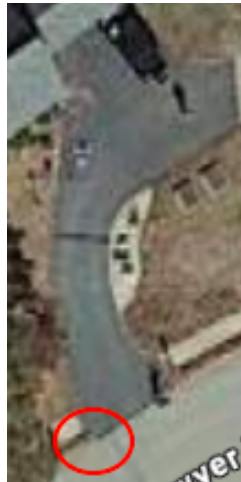
Image 1

Google Maps satellite image³ with sampling area circled

- A New Hampshire resident¹ collected one ~200 mL stormwater sample and one 250 mL (laboratory supplied) field blank during a moderate rain event on October 21, 2023 in front of a sloped, sealcoated driveway which drains directly to the street. (See Image 1)
- This sample was collected 94 days after sealcoating had been applied to the (~ 1,500 ft²) driveway.²

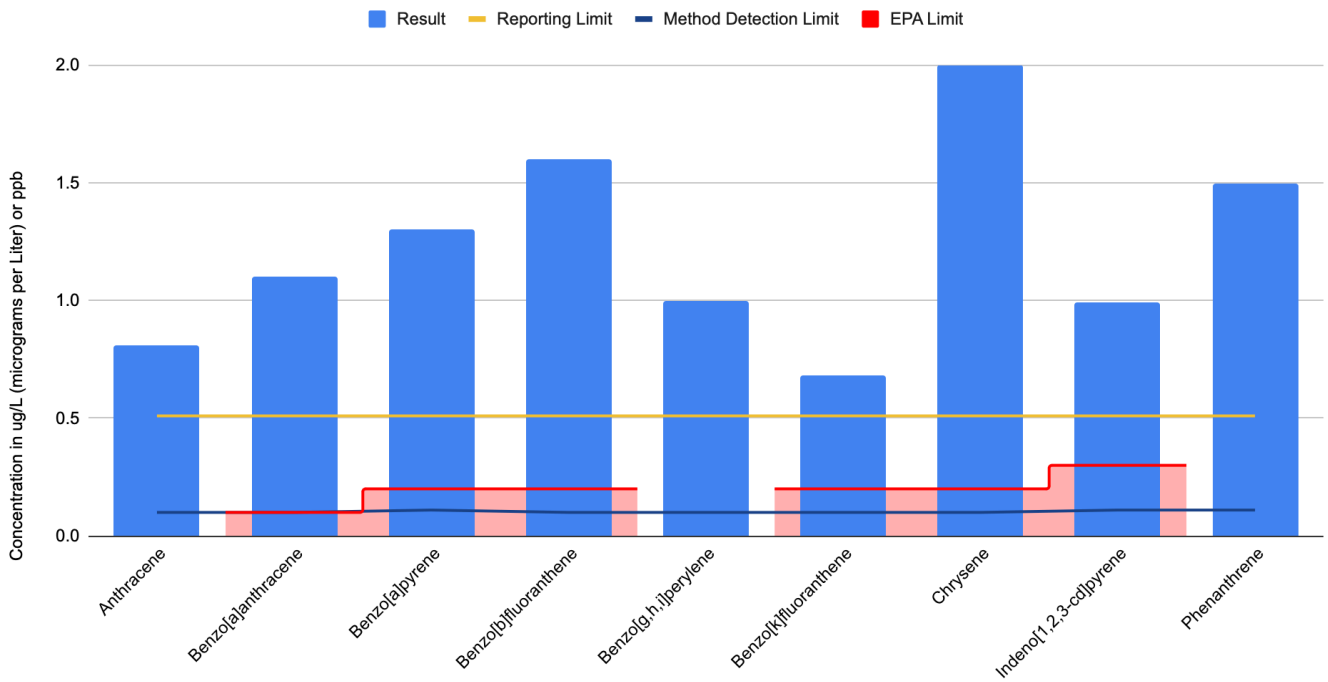
Figure 1a

Polycyclic Aromatic Hydrocarbons (PAHs) in a Driveway Runoff Sample (Fluoranthene and Pyrene Removed)

Sealcoating Applied: 19 July 2023; Stormwater Sampled: 21 Oct 2023 from Gov. Sawyer Lane, Dover, NH

- Six (6) of the detected analytes are considered carcinogenic⁴ and have federal regulatory limits. They are depicted with red in Table 1 and Figures 1a and 1b.⁵
- Each of these 6 carcinogenic analytes was detected at concentrations above its EPA maximum contaminant levels (MCL) in drinking water.
- The EPA recommends a maximum contaminant level *goal* (MCLG) of **zero** for carcinogenic PAHs in ambient water.⁶

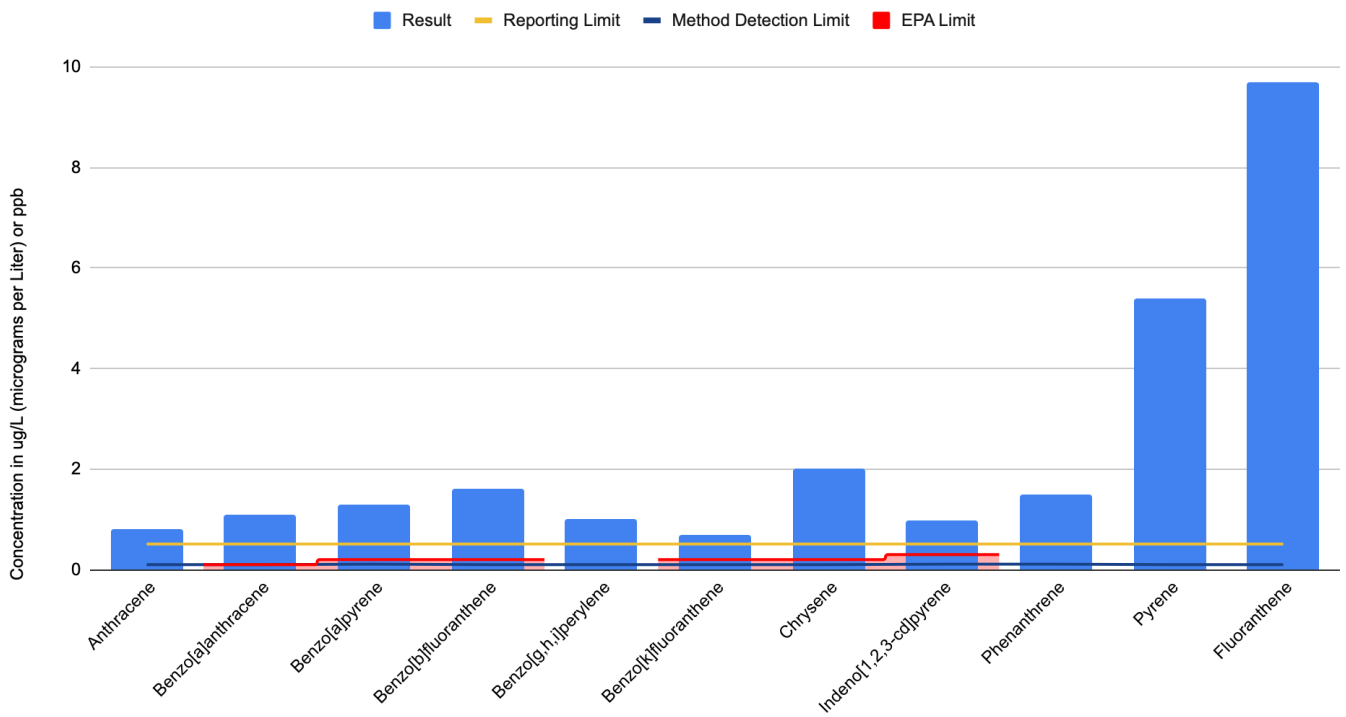
Figure 1b

Polycyclic Aromatic Hydrocarbons (PAHs) in a Driveway Stormwater Sample

Sealcoating Applied: 19 July 2023; Stormwater Sampled: 21 Oct 2023 from Gov. Sawyer Lane, Dover, NH
